# Manhole Inspection Summary

Manhole # S01CC2025MH

Insp Date: **9/27/06 12:24 PM**

**Location** Address: **3209 BANCROFT RD**

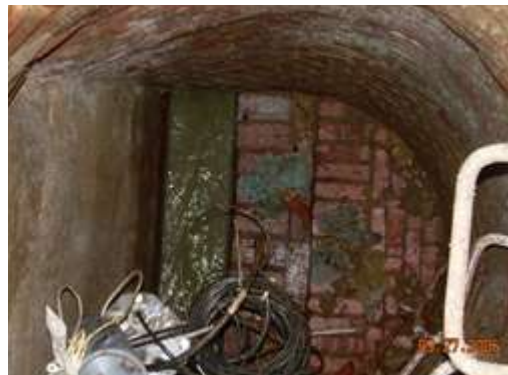
Top View

Condition: ☐ Sound ☐ Cracked ☐ Root Intrusion ☒ **Loose Brick** ☐ Deteriorated

Infiltration: ☐ None ☒ **Joint** ☐ Cracks ☐ Mortar ☐ Roots ☐ Wall

Count: **6** Missing: **0** ☒ **Corroded**

☒ **Evidence Of Surcharge** Depth: **2** (ft.) ☐ Active Surcharge Present

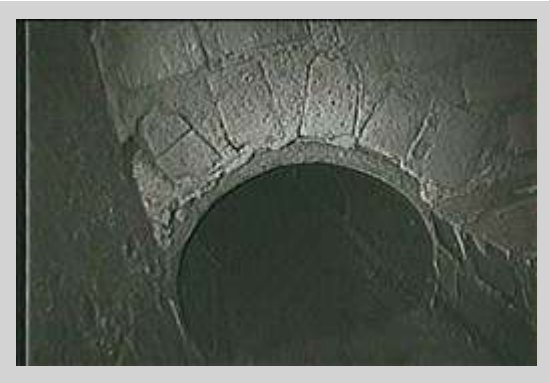
### 12 in. Circular Gravity Sewer Pipe Out @ 12 O'Clock

Pipe Material: **Clay** ☐ Pipe Lined

Invert Depth: **9.42** (ft.) Flow Characteristics: **Fast**

Infiltration: **None** Pipe Seal Cond: **Unknown**

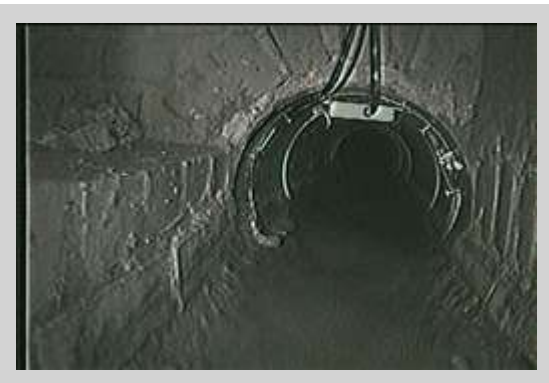
### 12 in. Circular Gravity Sewer Pipe In @ 6 O'Clock

Pipe Material: **Clay** ☐ Pipe Lined

Invert Depth: **9.38** (ft.) Flow Characteristics: **Fast**

Infiltration: **Evidence** Pipe Seal Cond: **Unknown**
